the electrical digest

ARC FURNACE TRANSFORMER FAILURES

BROSZ AND ASSOCIATES

Volume 1
Number 11

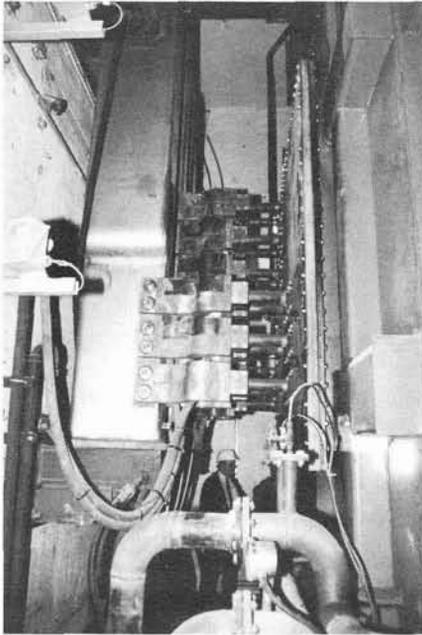
*10,000 AMP Connections:
Overheating on secondary (750V) side.*

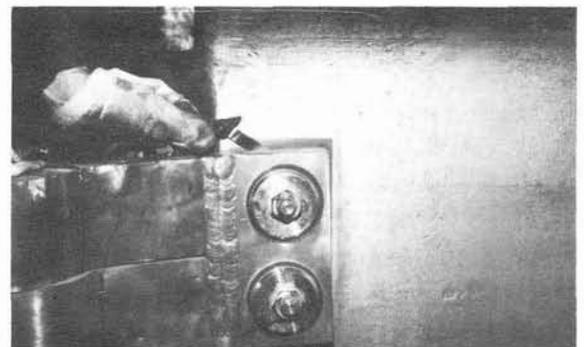
*Close-up view of a defective 10,000 AMP bus connection.
Note: Feeler gauge between mating surfaces.*

On a particular 60,000 Amp, 750V, 50 Hz arc furnace unit the high current main connections to the furnace were found to have gaps between the connections.

Severe burning and pitting found at 10,000 Amp rated connections was evidence of extreme heat. A feeler gauge could be pushed between the connection surfaces. The heat necessary to produce such pitting and burning had to be extremely high. This heat would be transferred to the transformer windings producing higher than normal temperatures in the winding and oil. This with the eccentric duty of the system combined to cause hot spots within the unit. Hot spots may lead to the deterioration of the insulation around the windings and sludging and the production of other contamination in the insulating oil.

Insulation failure, whether in solids or liquids will lead eventually to total failure and the loss of the unit. The lesson here is that all current connections must have maximum surface contact and run cool. Keeping highly fluctuating and sometimes severe overcurrent conditions within acceptable temperature limits will make insulation preservation easier. Installation checks to ensure good contacts added to knowledgeable preventive maintenance work, should aim for these requirements.

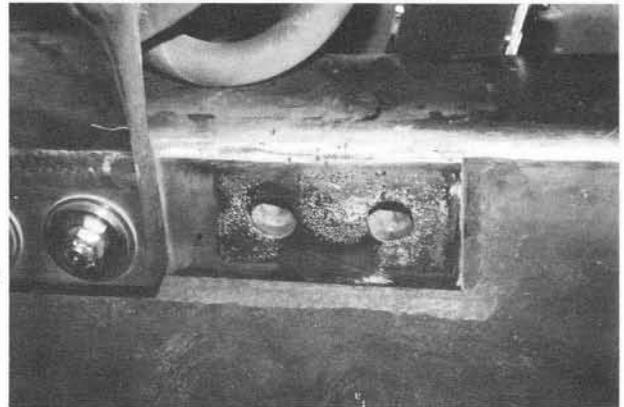
Close-up view of deteriorated/overheated 10,000 AMP water-cooled connection.

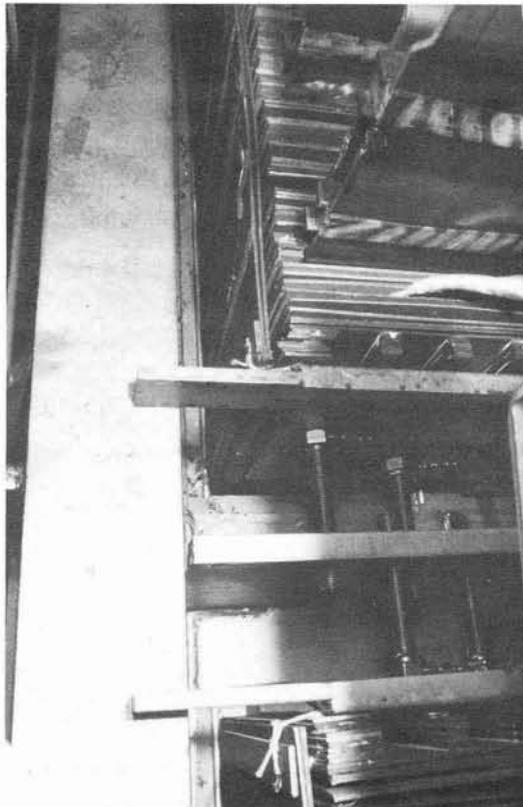
In another case, where the furnace transformer was designed using a shell form configuration, failure was due to the inability to control short circuit forces. This is unusual since shell form designs are always believed to be mechanically stronger than core form designs.

Shell form transformer windings are considered easier to clamp and hold down during short circuit behaviour, but in this case the internal clamps loosened and did not hold and typical short circuit winding failures were found in the windings (see photo). Of course, the failure could have been due to extreme conditions within the general arc furnace circuit such as inadequate reactance, but, nevertheless, the evidence in this case suggested deficient clamping pressures. Often, with continuous but erratic mechanical pummeling such as during the operation of the arc furnace, clamps can become loose and certainly release the

Shell form furnace transformer with loose core and shorted high voltage turns.

original design pressures. Also windings tend to shift and shrink with age and the combination of this and tough mechanical pounding can add to the changing and deteriorating clamping pressures. The solution - to ensure during any maintenance inspection of the transformer that the clamping pressures are adequate and adjusted if necessary.

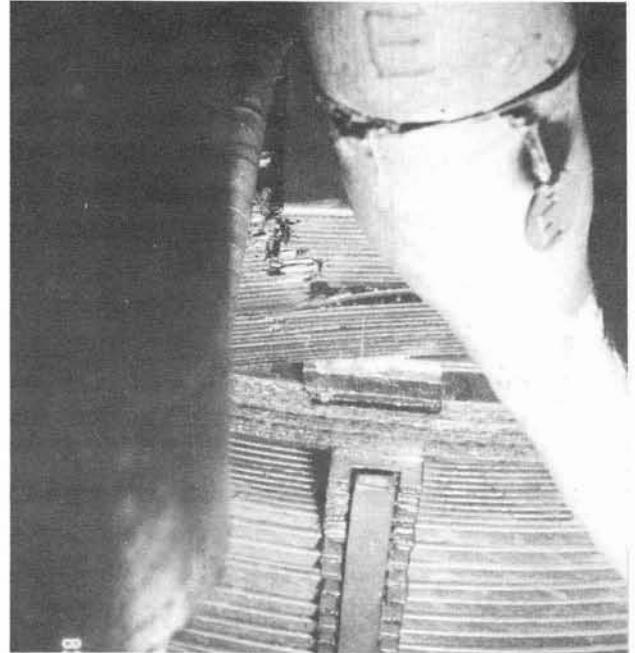
Broken high voltage coil blocking. Due to short circuit forces.

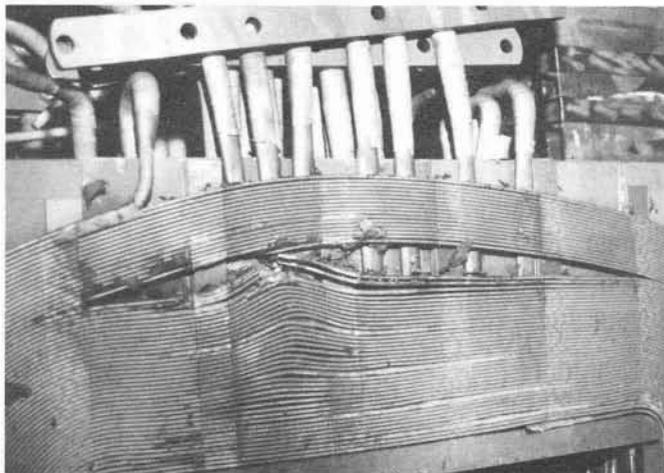
Shell type furnace transformer. High voltage winding, turn-to-turn failure.

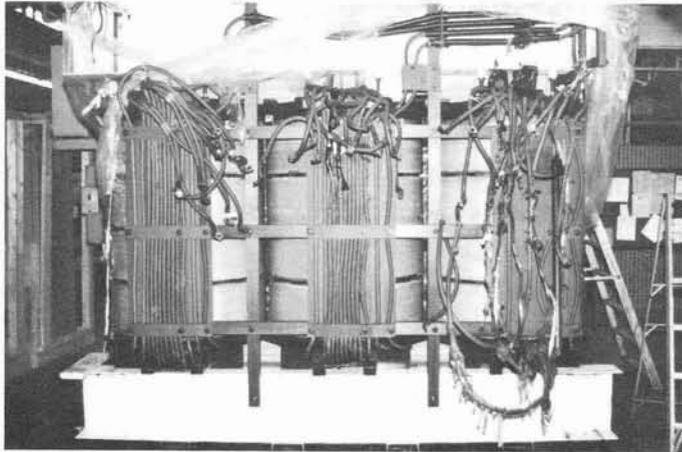
A further problem was found in another transformer with loose extra-flexible primary leads. Again, insufficient consideration of the mechanical forces set up by the tough conditions experienced by arc furnace transformers was found to be the reason why the flexible lead insulation became chuffed and worn, resulting in a short circuit fault.

Failure of extra flexible, high voltage connections.

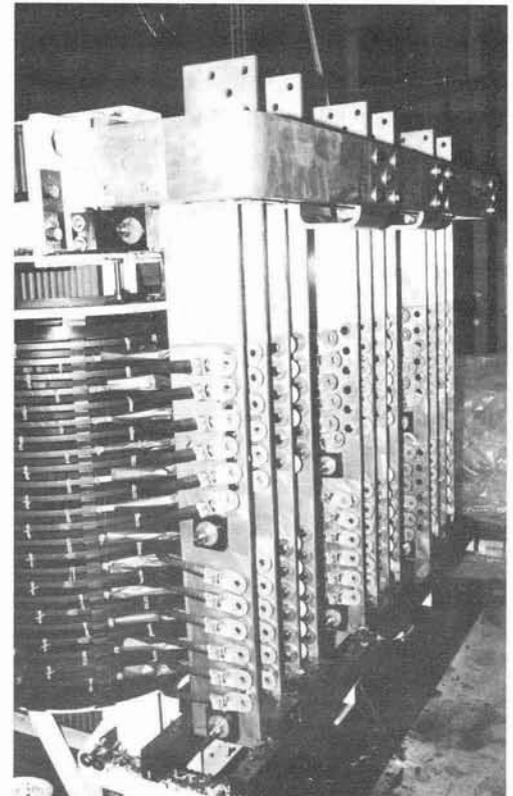
Internal connection failure on 18 MVA transformer.
